**KV 38 - Thutmes I Dyn. XVIII**  
Plan, sections 1:125, Axonometric

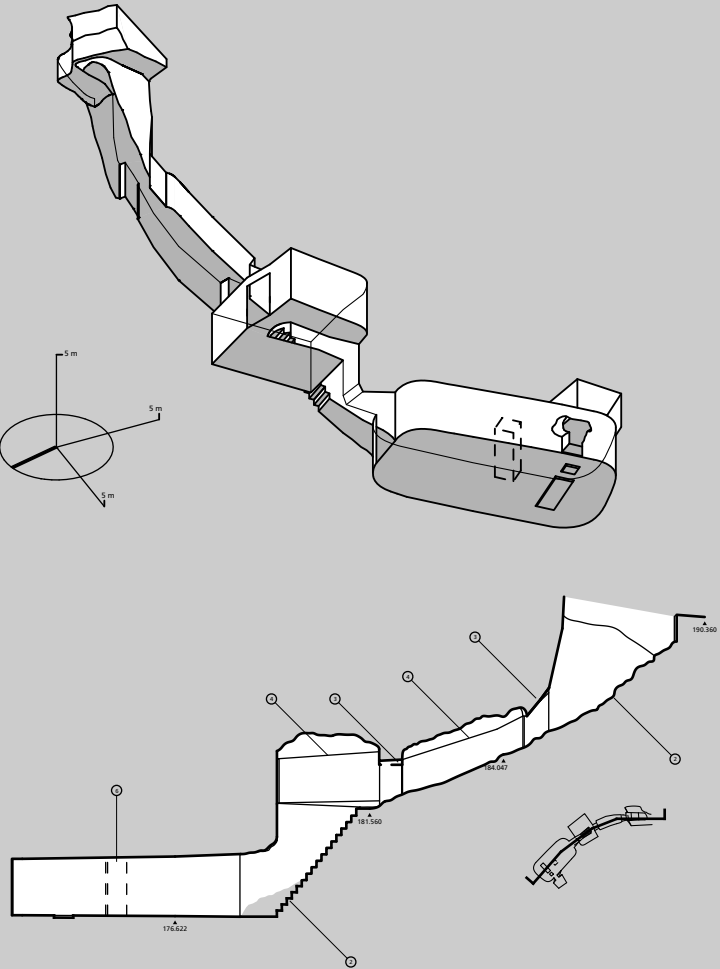
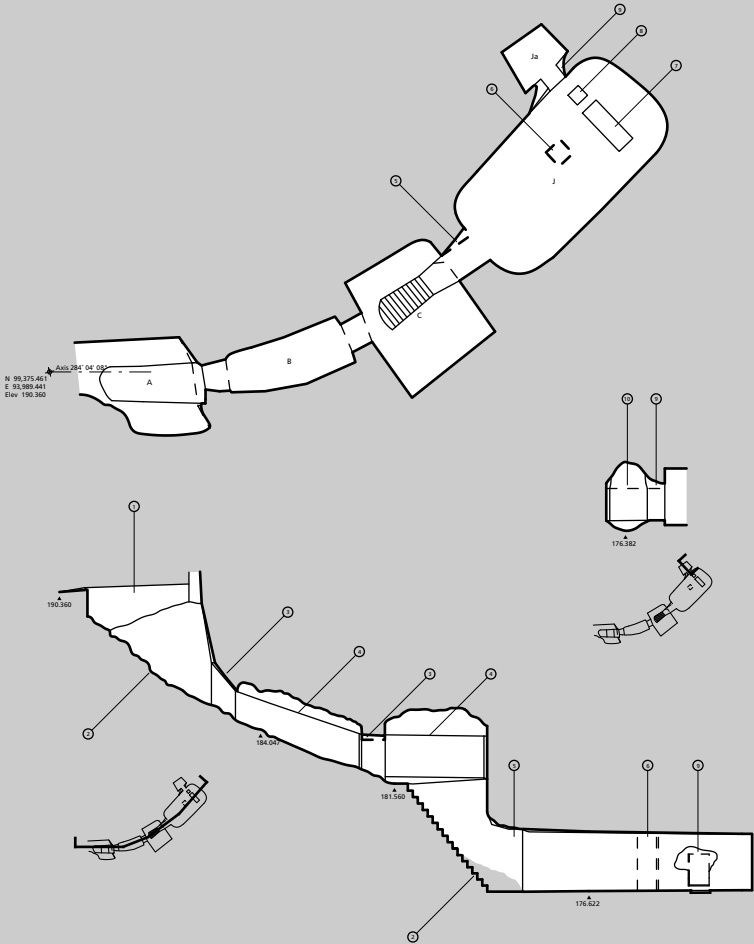
NOTES	
1	Modern protective wall.
2	Original steps damaged, covered with debris.
3	Lintel broken.
4	Traces of original ceiling; ceiling collapsed above.
5	Jamb broken.
6	Pillar destroyed; reported by Lorez in 1899.
7	Sarcophagus emplacement: location and size approximate. Sarcophagus now in Egyptian Museum.
8	Canopic chest emplacement: location and size approximate. Chest now in Egyptian Museum.
9	Gate badly damaged.
10	Chamber badly damaged.
